REFINING NZ
Your Energy Hive

Media Release

22 September 2017
11am

Pipeline repair: status update

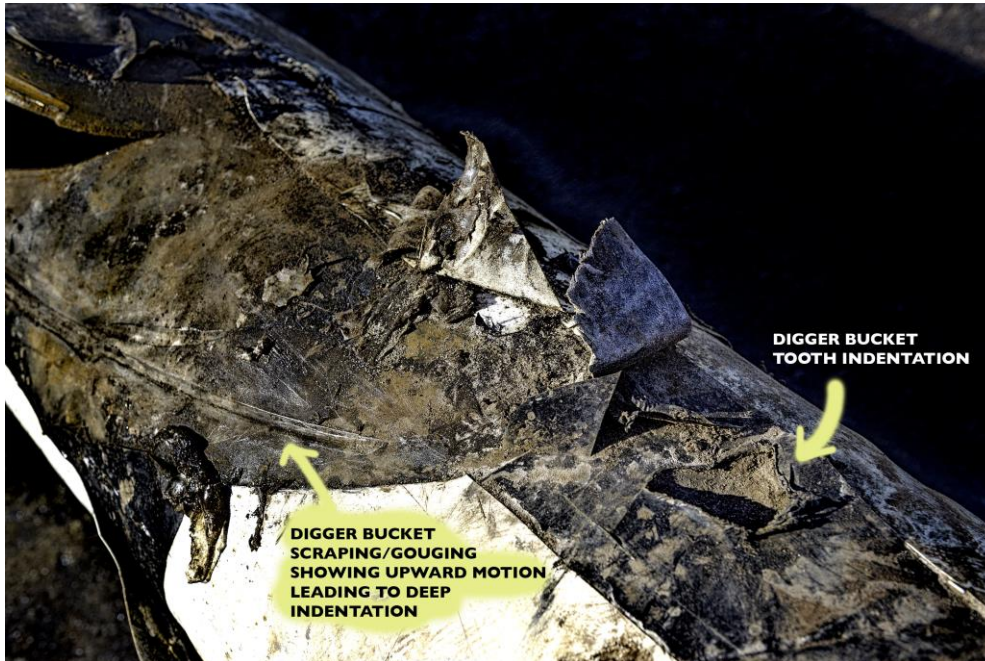
INSERT IMAGE #1

Image #1 shows the digger bucket tooth indentation, as well as the scraping and gouging of the digger bucket's travel over the pipe.

Both images indicate how the protective insulation was damaged.

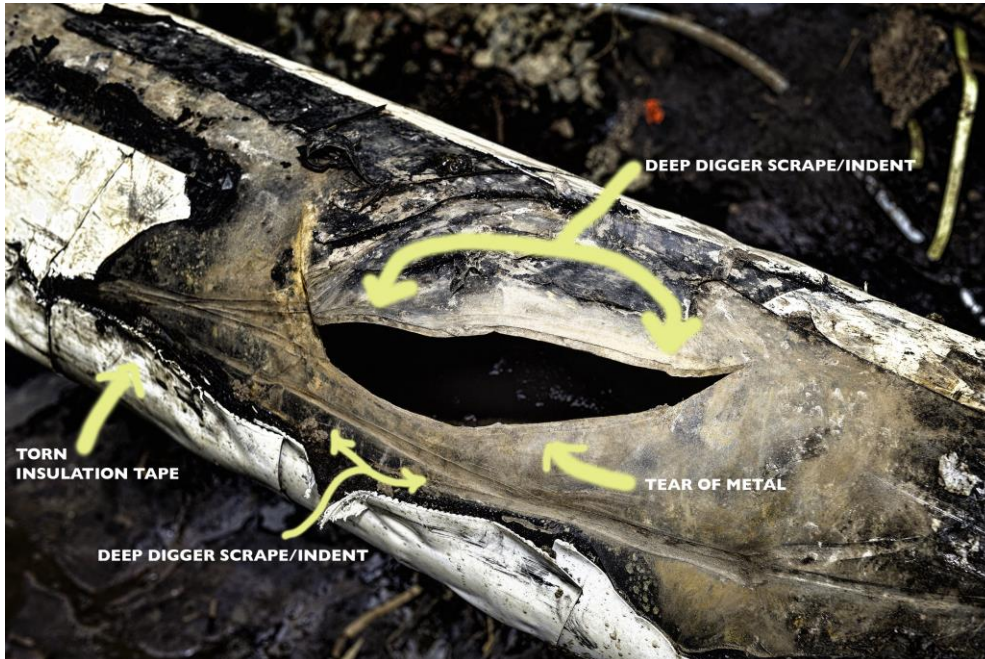
INSERT IMAGE #2

Image #2 shows the rupture (tear of metal) which eventuated on Thursday last week, as a consequence of the earlier damage.
